# Roof Inspection Report

ID: sample\_78a2\_202504240001

12 Maple Avenue  
Greenfield, NZ 6012

Longrun / Colorsteel

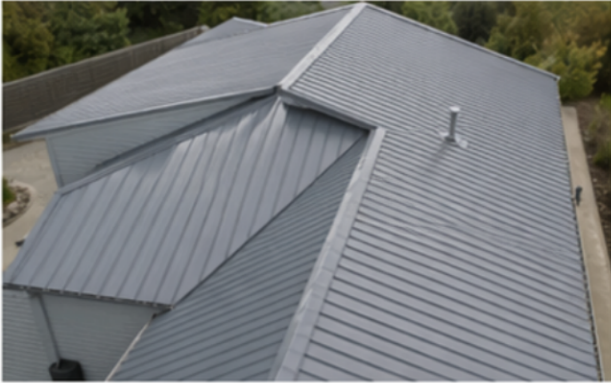
P1 • Linked to F3

- F3 • General roof observation** **Low**

Risk: Low The general roof area appears serviceable with no significant visible defects noted at the time of inspection. Repair priority: Routine maintenance Maintenance planning: Monitor condition and address during normal maintenance cycles.

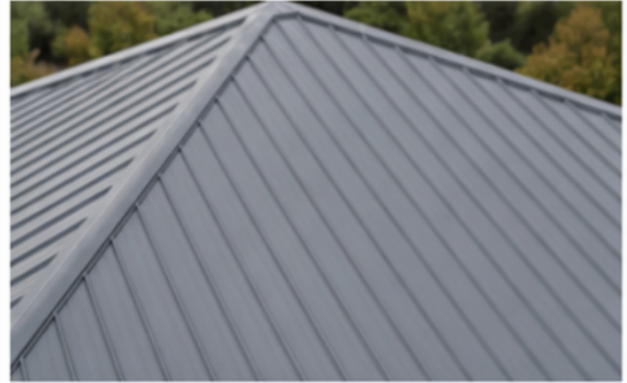
P2 • Linked to F2

---
- F2 • Longrun roof condition** **Medium**

Risk: Medium The longrun roof is in fair condition with minor visible wear. Repair priority: Repair recommended soon Maintenance planning: Arrange targeted remedial work in the short term to prevent further deterioration.

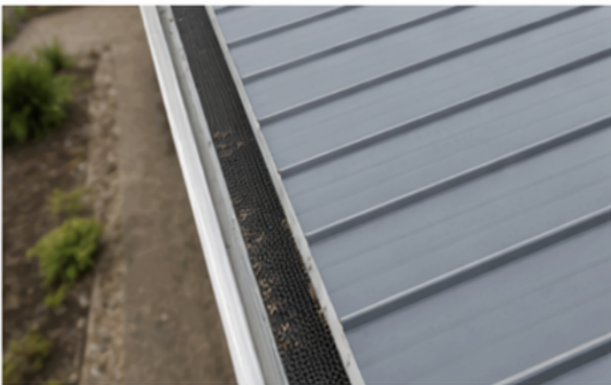
P3 • Linked to F1

● **F1 • Gutter / drainage**

Risk: High The gutter section shows debris build-up and standing water in multiple areas, increasing the risk of overflow, back-up, or associated moisture entry if left unaddressed. Repair priority: Urgent repair advised  
Maintenance planning: Prompt corrective action is recommended to reduce the risk of water ingress, failure, or further damage.

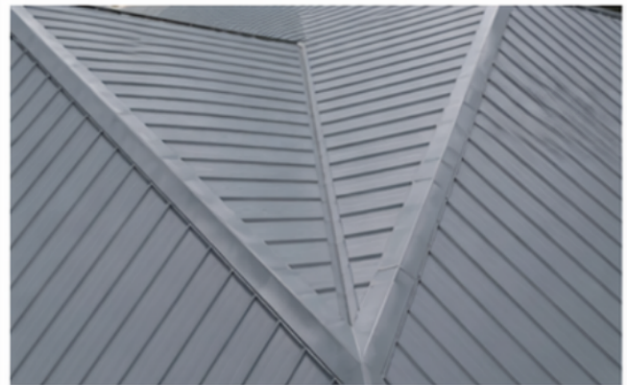
P4 • Linked to F4

---
- F4 • Valleys / water channels** **Low**

Risk: Low The valley section appears serviceable with no significant visible defects noted at the time of inspection. Repair priority: Routine maintenance Maintenance planning: Monitor condition and address during normal maintenance cycles.

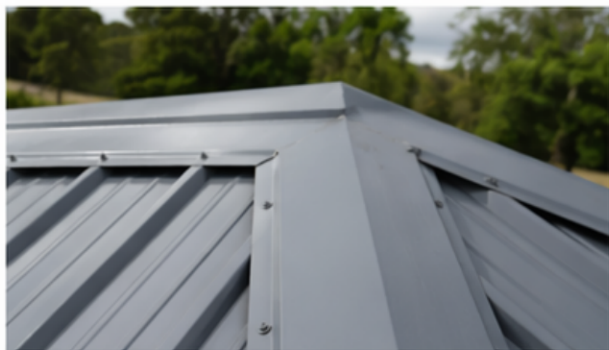
P5 • Linked to F6

---
- F6 • Ridge / hip condition** **Medium**

Risk: Medium The ridge / hip section shows moderate wear to sealants and caps. Repair priority: Repair recommended soon Maintenance planning: Arrange targeted remedial work in the short term to prevent further deterioration.

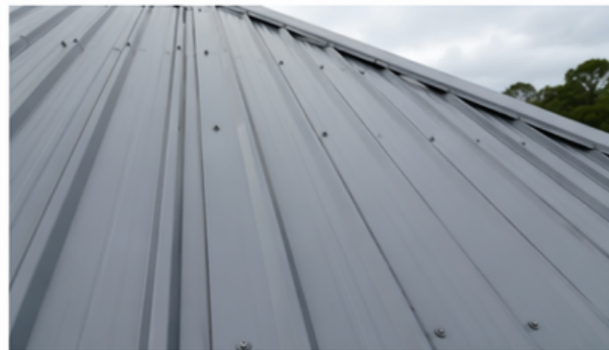
P6 • Linked to F5

---
- F5 • Screws check** **Medium**

Risk: Medium A number of fasteners show signs of corrosion or minor back-out. Repair priority: Repair recommended soon Maintenance planning: Arrange targeted remedial work in the short term to prevent further deterioration.

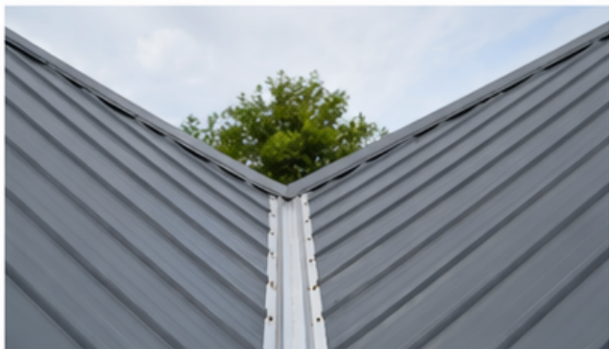
P7 • Linked to F8

● **F8 • Roof flashings**

Risk: High Several roof flashings around wall intersections and penetrations show lifted edges and deteriorating sealant. This increases the risk of water ingress during wind-driven rain. Repair priority: Urgent repair advised  
Maintenance planning: Arrange targeted remedial work in the short term to prevent further deterioration.
