Roof Inspection Report

Comprehensive Report

Roof type / material
Longrun / Colorsteel

Property address
25 Oak Avenue
Greenfield, NZ 6012

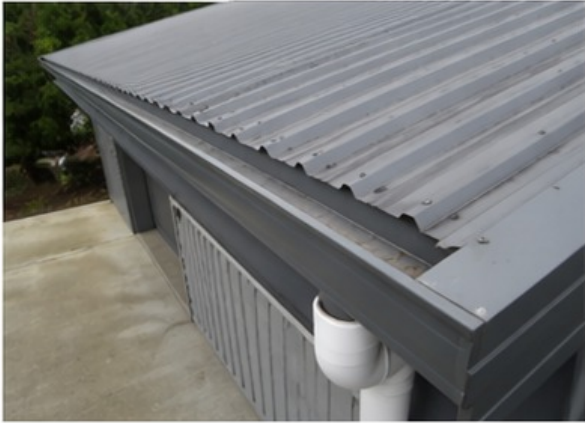
P1 • Linked to F1

● F1 • Gutter / drainage

High

Risk: Debris build-up in sections of the guttering system is restricting flow and causing standing water pockets. This condition increases the risk of overflow during heavy rainfall and potential water ingress to roof edges and eaves. Urgent repair advised. Maintenance planning: Prompt corrective action is recommended to restore proper drainage and reduce overflow risk.

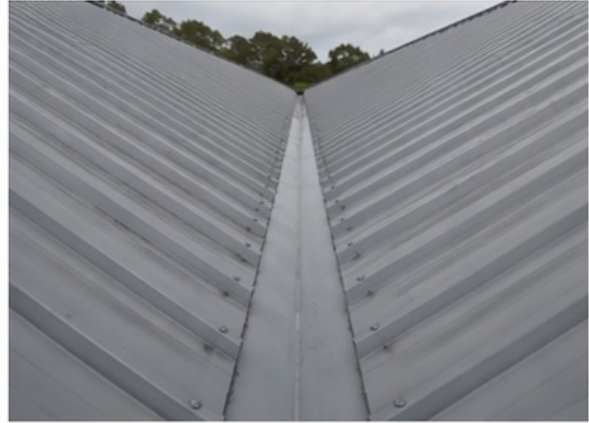
P2 • Linked to F2

● F2 • Valleys / water channels

High

Risk: Debris retention and localized water staining were observed in valley areas, which increases the risk of moisture entry and corrosion over time. Urgent repair advised.

Maintenance planning: Prompt corrective action is recommended to maintain effective drainage and reduce the risk of water ingress.

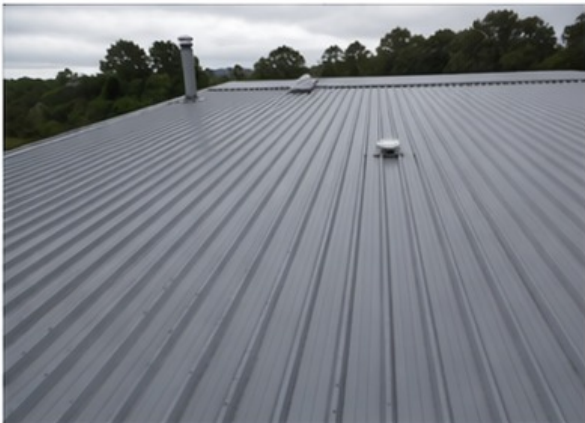
P3 • Linked to F3

● F3 • Longrun roof condition

Medium

Risk: The longrun roofing shows visible age-related wear and minor coating weathering. While no active leaks were observed, ongoing deterioration is likely if left unaddressed. Maintenance planning: Repair recommended soon to extend service life and prevent future issues.

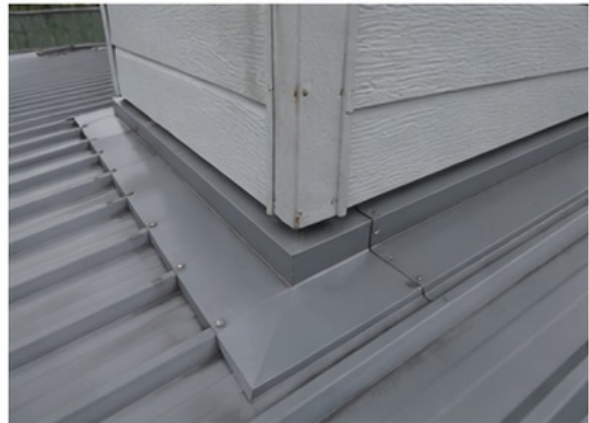
P4 • Linked to F4

● F4 • Flashings condition

High

Risk: Flashing sections show lifted edges and localized deterioration around key junctions, presenting a risk of water ingress at these interfaces. Urgent repair advised. Maintenance planning: Prompt corrective action is recommended to restore watertight seals at junctions.

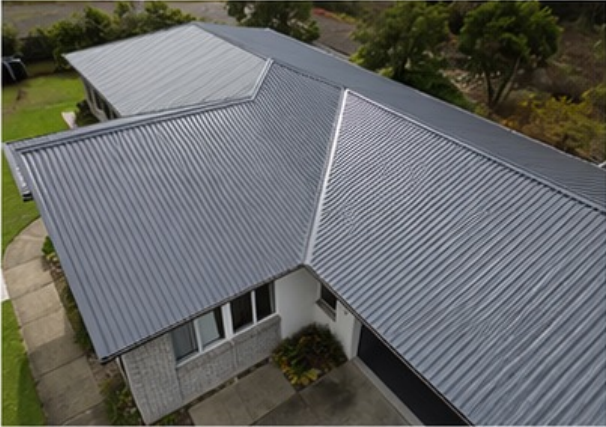
P5 • Linked to F5

● F5 • General roof observation

Low

Risk: The main roof field appears broadly serviceable with no major deformation or widespread failure noted. Overall condition is consistent with normal wear. Maintenance planning: Continue routine maintenance and monitoring as part of standard care cycles.

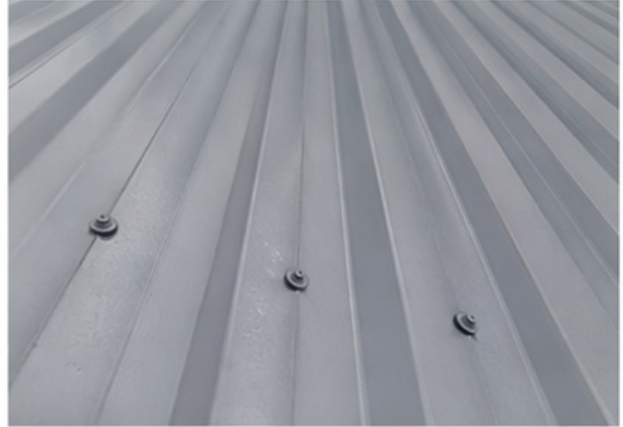
P6 • Linked to F6

● F6 • Screw / fastener condition

Medium

Risk: Some fasteners show signs of back-out, corrosion, or washer wear, which can compromise panel security and weather performance. Maintenance planning: Targeted remedial work is recommended to replace or re-secure affected fasteners.

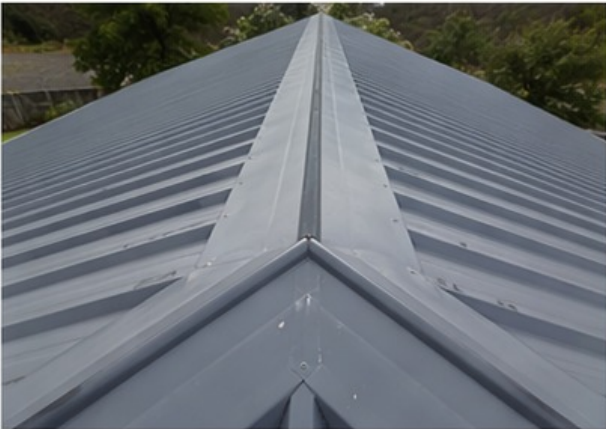
P7 • Linked to F7

● F7 • Ridge / hip condition

Medium

Risk: The ridge and hip detailing shows localized wear and moderate sealant aging, which may lead to moisture ingress if not addressed. Repair priority: Repair recommended soon. Maintenance planning: Arrange targeted remedial work in the short term to prevent further deterioration.

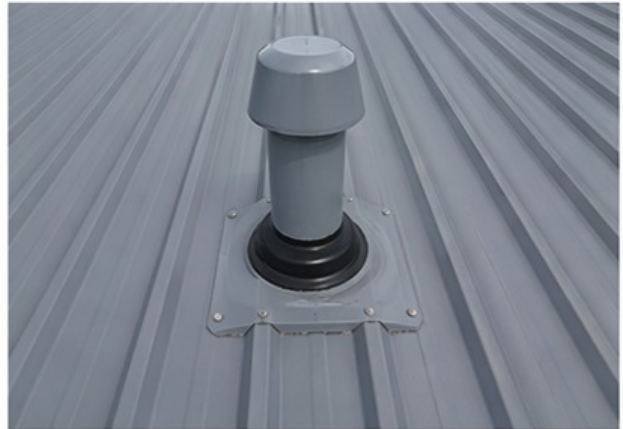
P8 • Linked to F8

● F8 • Roof penetrations

Medium

Risk: Penetrations show early sealant cracking and separation around penetrations, which increases the risk of water ingress. Repair priority: Repair recommended soon. Maintenance planning: Arrange targeted remedial work in the short term to prevent further deterioration.

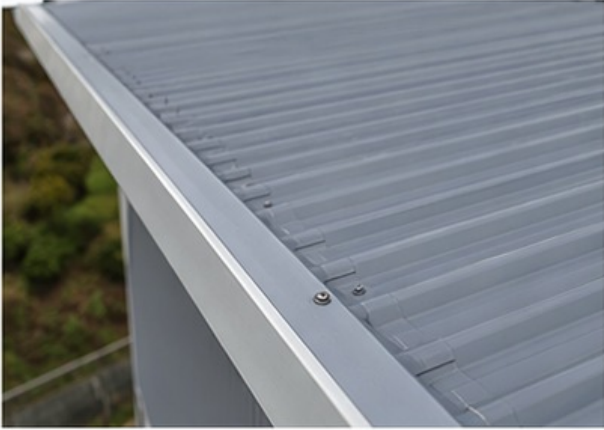
P9 • Linked to F9

● F9 • Barge / edge condition

Medium

Risk: The edge trim and barge details show moderate aging and require monitoring, with minor repairs recommended to maintain performance. Repair priority: Repair recommended soon. Maintenance planning: Monitor condition and address during routine maintenance cycles.

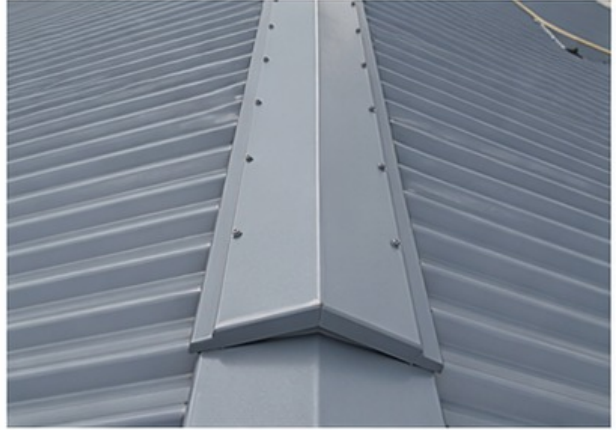
P10 • Linked to F10

● F10 • Capping condition

Medium

Risk: The capping lines remain largely serviceable but show localized movement and weathering, which could lead to water ingress if not addressed. Repair priority: Repair recommended soon. Maintenance planning: Arrange targeted remedial work in the short term to prevent further deterioration.

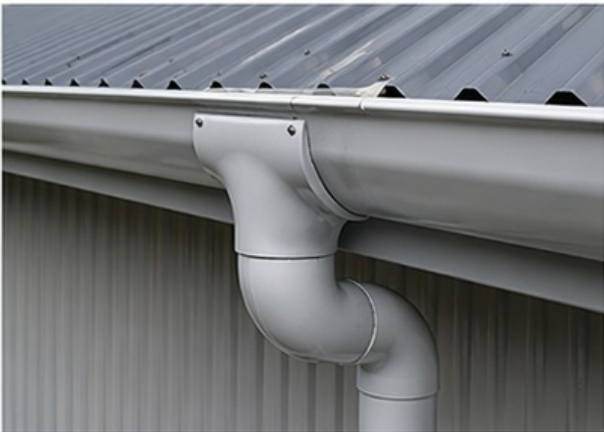
P11 • Linked to F11

● F11 • Downpipe outlets

Medium

Risk: Downpipe outlets show debris accumulation and minor staining that may impede drainage and cause water to pond. Repair priority: Repair recommended soon. Maintenance planning: Routine repair and cleaning recommended to ensure proper water discharge.

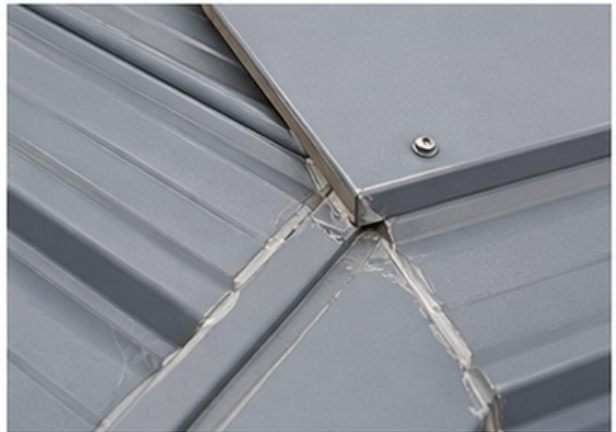
P12 • Linked to F12

● F12 • Sealant / junctions

Medium

Risk: Medium The sealant lines at key roof junctions show weathering and early failure risk. Repair priority: Repair recommended soon Maintenance planning: Targeted maintenance recommended.

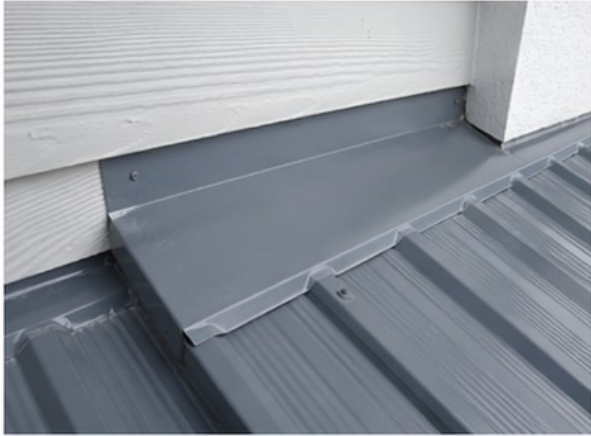
P13 • Linked to F13

● F13 • Apron flashing

Low

Risk: Low The apron flashing areas appear serviceable with only minor weathering. Repair priority: Routine Maintenance planning: Routine monitoring advised.

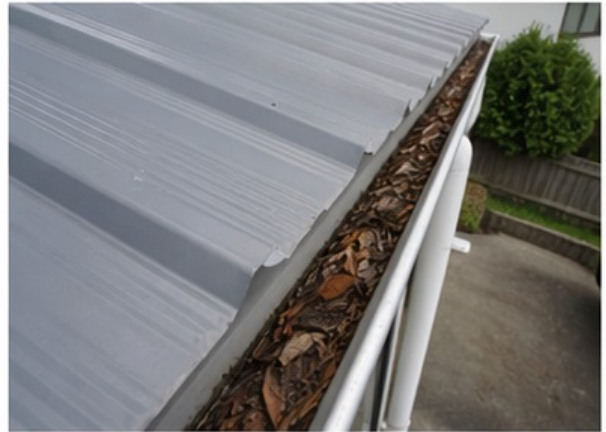
P14 • Linked to F14

● F14 • Gutter guard / debris

Low

Risk: Low Some debris accumulation is present, but no severe blockage in inspected sections. Repair priority: Routine Maintenance planning: Routine cleaning advised.

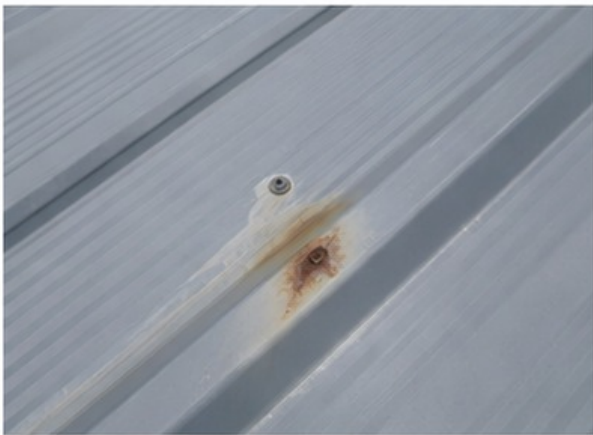
P15 • Linked to F15

● F15 • Corrosion watch

Low

Risk: Low Isolated surface corrosion staining only, with no widespread structural concern visible. Repair priority: Routine Maintenance planning: Monitor during maintenance cycles.

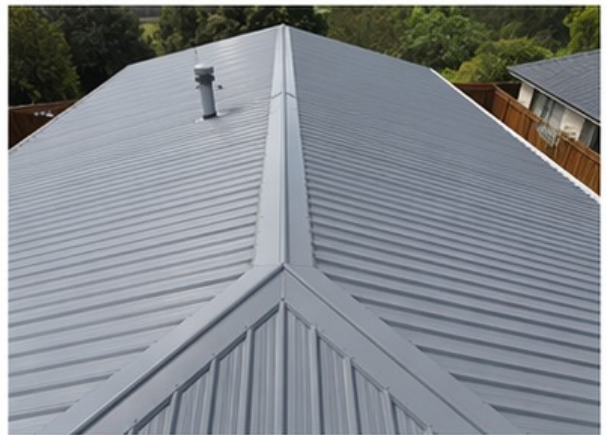
P16 • Linked to F16

● F16 • Maintenance summary

Low

Risk: Low The roof remains generally serviceable overall, but a planned programme of cleaning, resealing, and localized repairs is recommended to preserve performance. Repair priority: Routine Maintenance planning: Recommended.
