# RoofVision Roof Inspection Report

## Inspection

Date: 18 Mar 2026

4 Smith Street

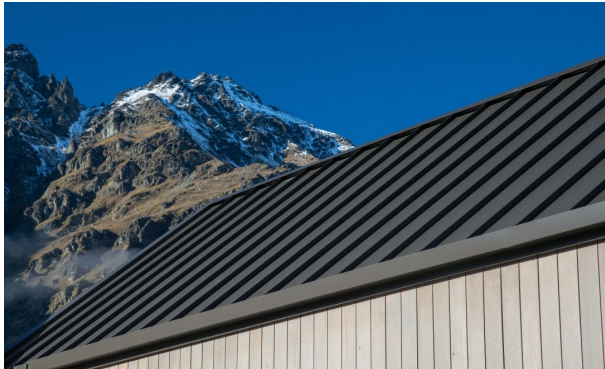
Photo evidence

- **New Longrun Roof Condition** **Low**  
The Longrun roof appears brand new, likely providing effective protection against water ingress. Regular monitoring is advised to maintain its condition. Recommendation: Schedule periodic inspections to monitor roof condition. Assumptions: Assessment based on visual inspection only; no invasive testing performed.

- **Hidden Fixing Flashings in Good Condition** **Low**  
Flashings on the Longrun roof use a hidden fixing system, which appears intact and reduces water infiltration risk. Regular inspections are advised to maintain their effectiveness. Recommendation: Conduct periodic inspections to ensure flashings remain secure. Assumptions: Assessment based on visual inspection only; no invasive testing performed.
